# **Interstate 80, Section 17M**

## **Water Resources Delineation Report 2019 Addendum - Expanded Study Area**

**July 2019**

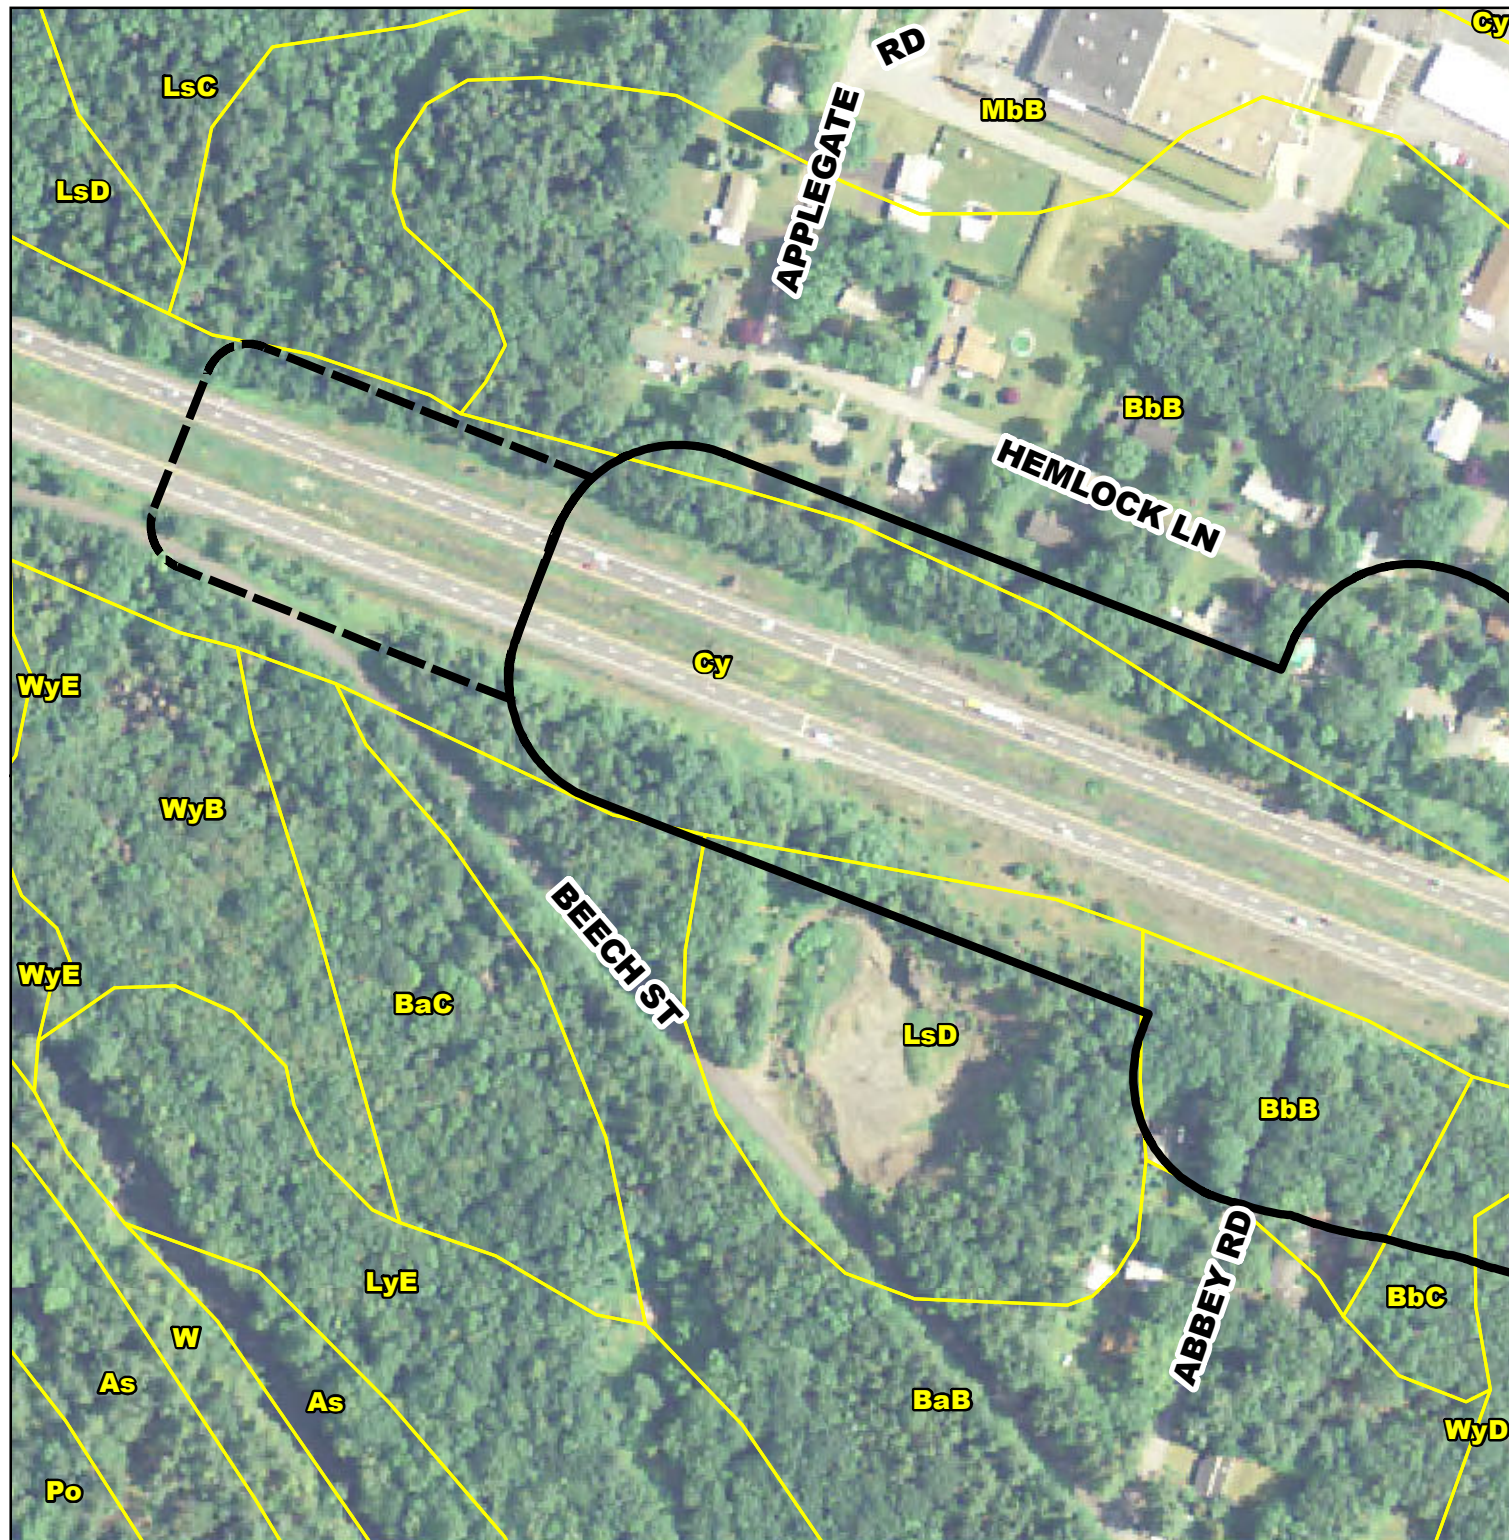
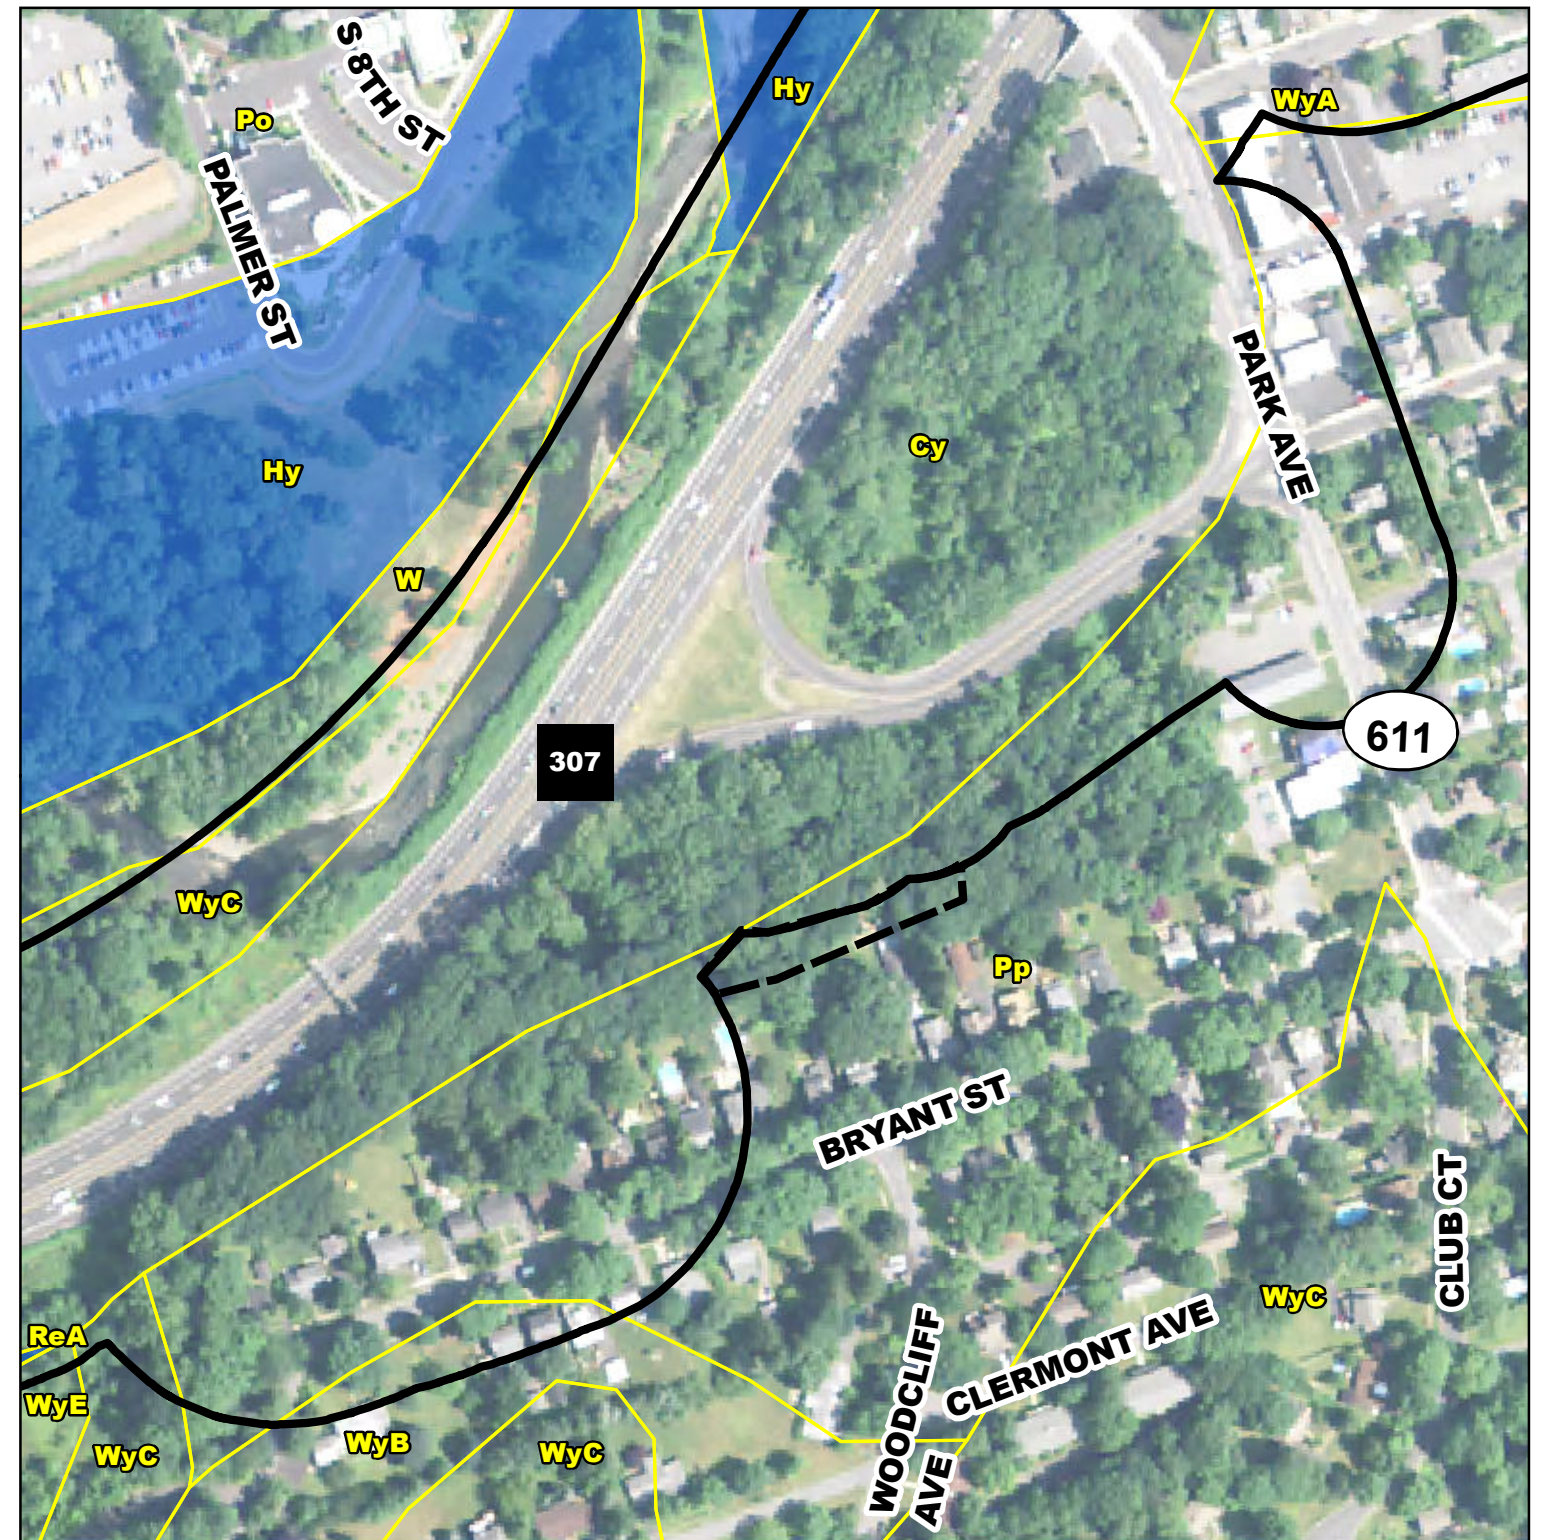
**FIGURE 2A: PROJECT AREA SOILS**

The Soil Survey identified one soil type that is considered hydric or is known to contain hydric soil components within the 2019 expanded study areas (*Figure 2*). *Table 1* provides a brief overview of the hydric soils. A description of all the soils within the 2019 expanded study areas is contained in *Table 2*.

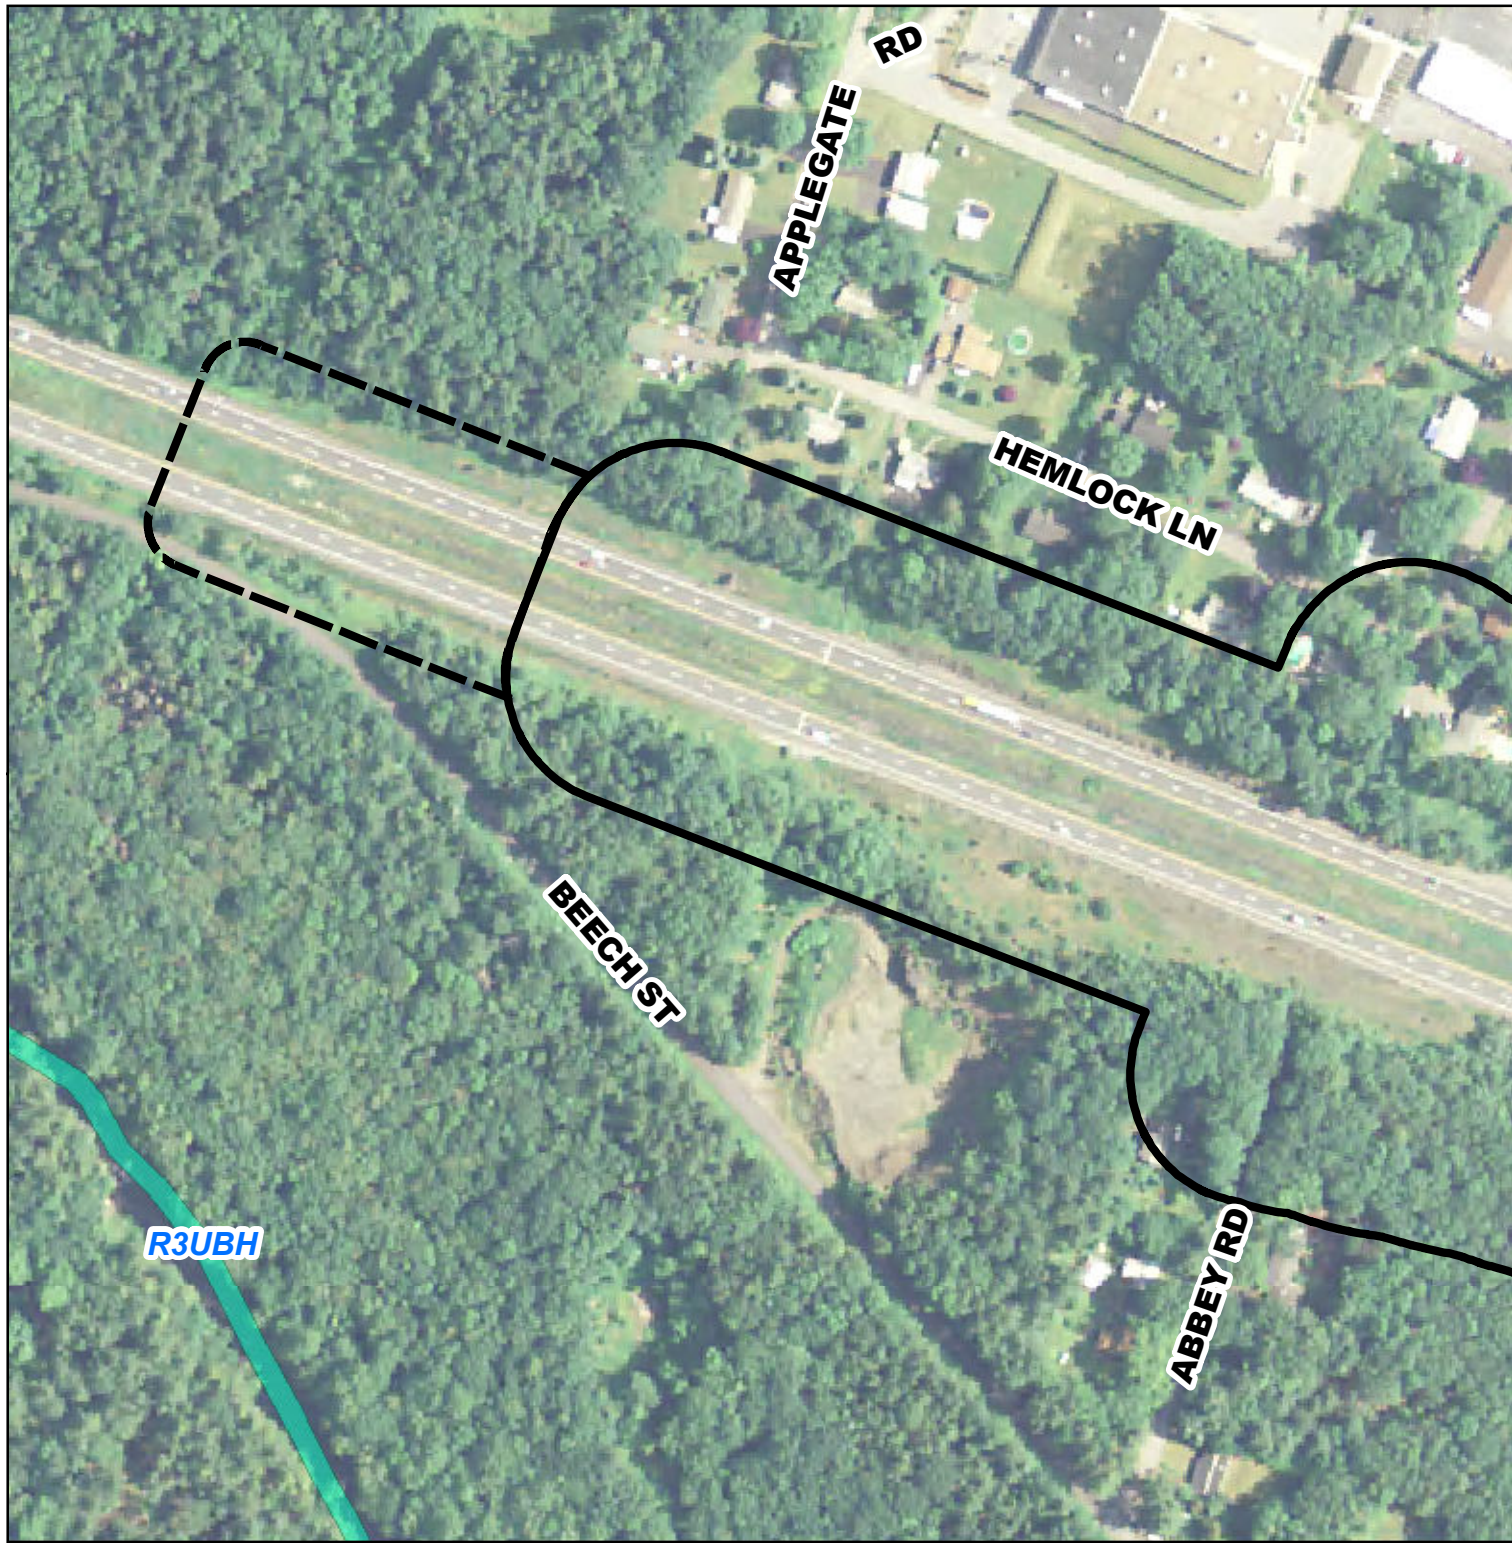
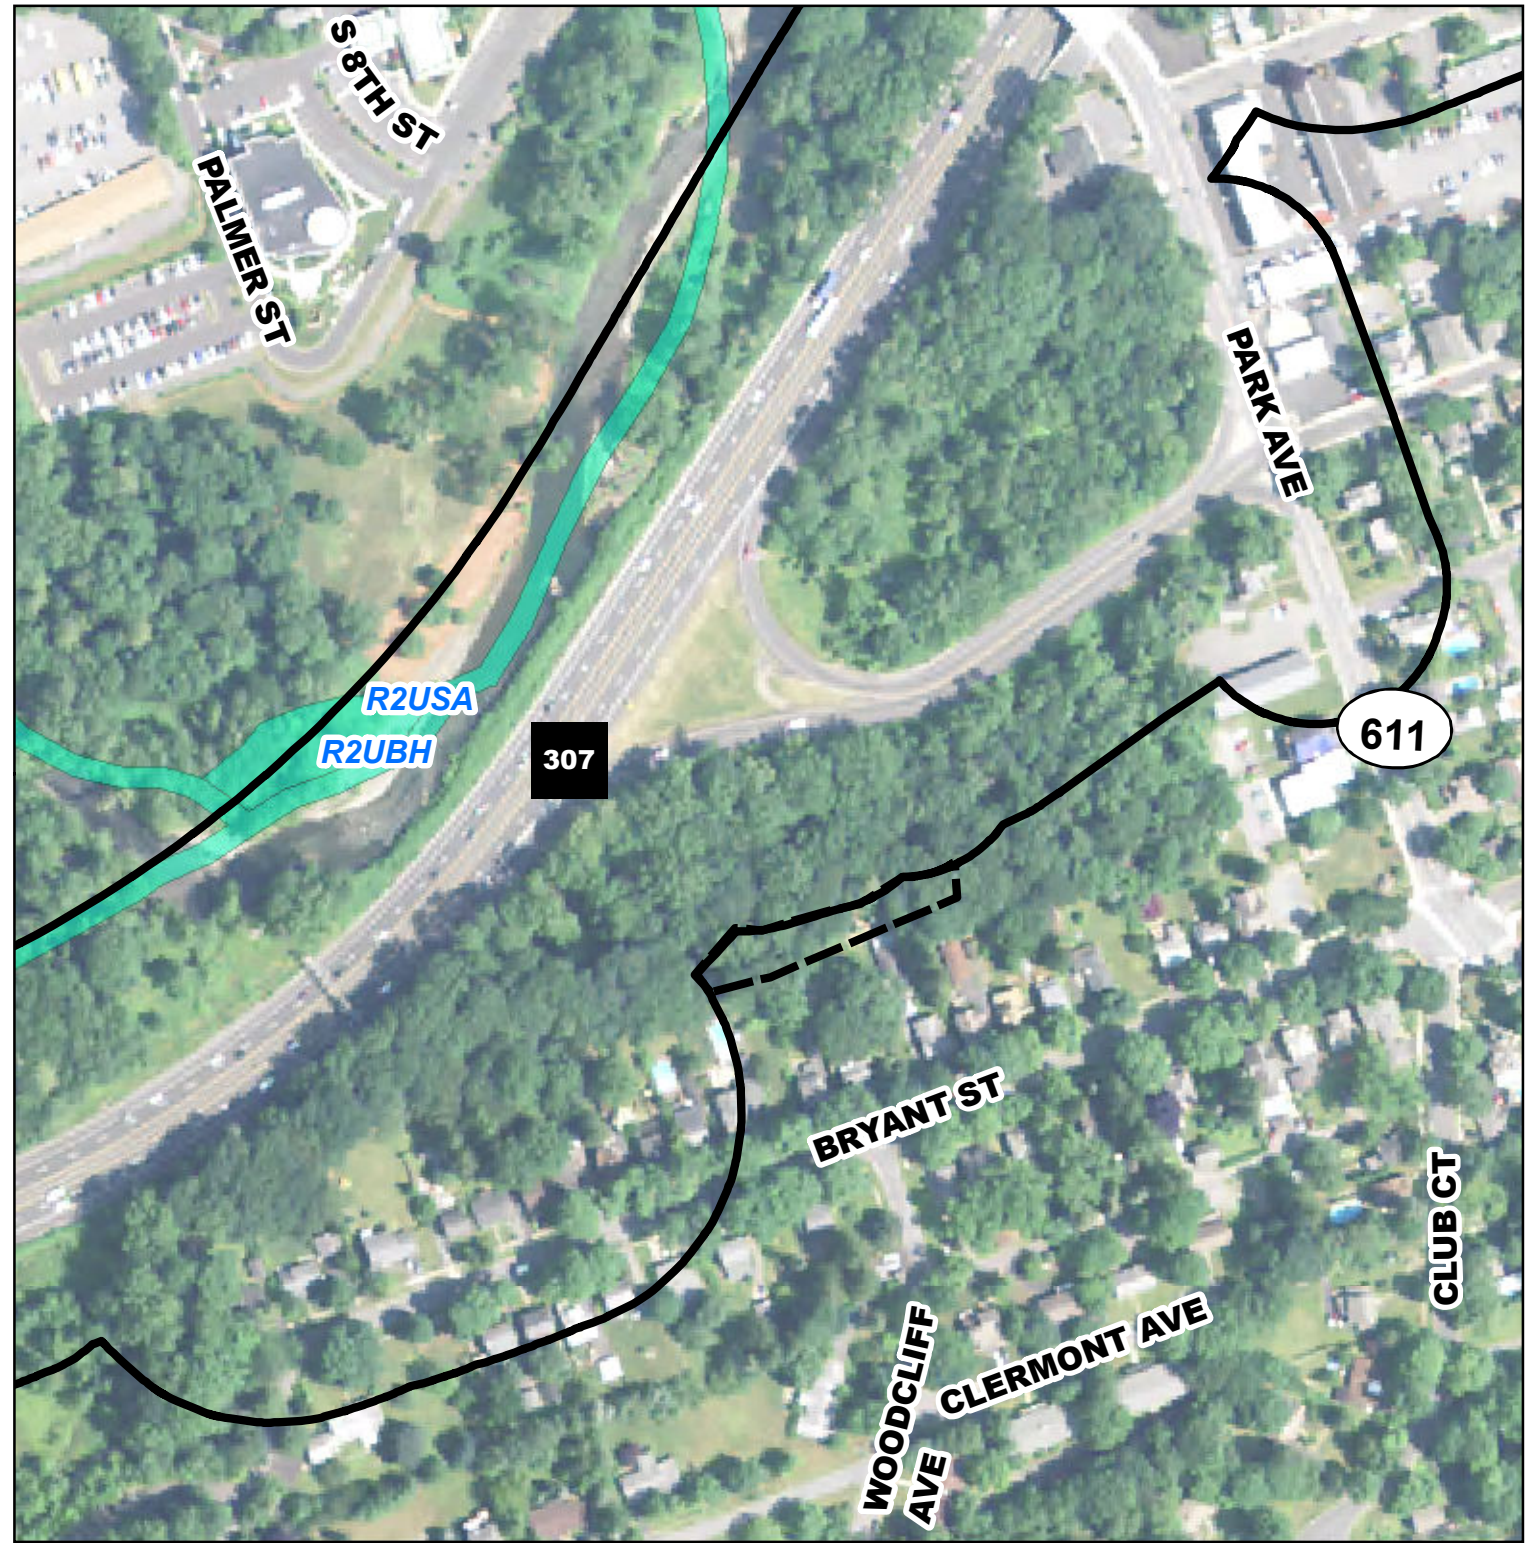
**FIGURE 3A: PROJECT AREA  
NWI WETLANDS**

Review of the NWI mapping did not identify any wetland systems located within the 2019 expanded study areas (*Figure 3*). However, two riverine systems were identified: One riverine unknown perennial, unconsolidated bottom, permanently flooded (R5UBH) feature that coincides with Pocono Creek and Flagler Run and one riverine unknown perennial, unconsolidated shore, seasonally flooded feature (R5USC) that is associated with Pocono Creek as well.

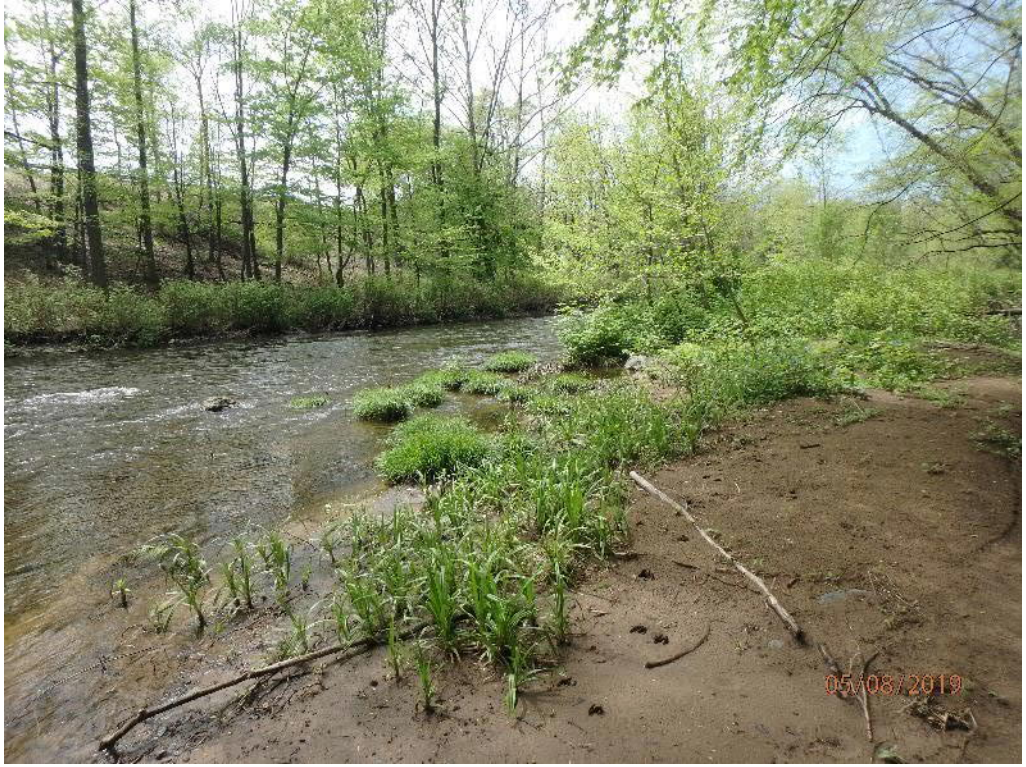
<b>Photograph:</b> 1	<b>Date:</b> 05/08/2019

<b>Feature ID:</b> Watercourse WW-3-00		
<b>Direction:</b> West (Upstream)		
<b>Description:</b>  View of Watercourse Pocono Creek (WW-3-00) facing upstream.

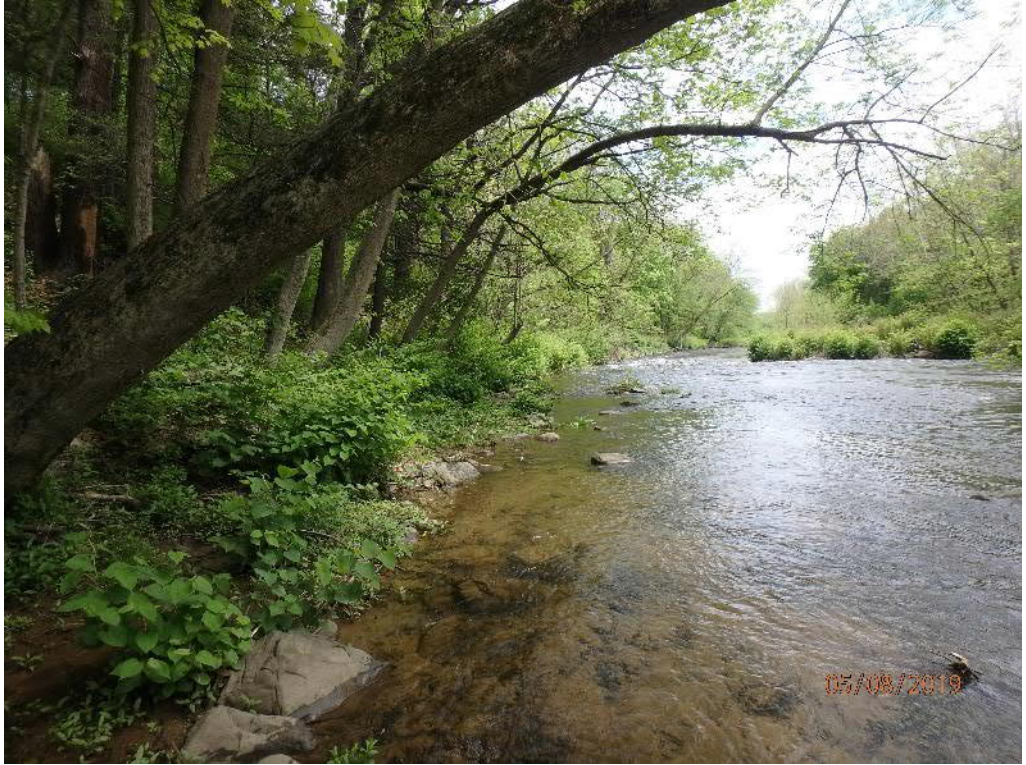
<b>Photograph:</b> 2	<b>Date:</b> 05/08/2019

<b>Feature ID:</b> Watercourse WW-3-00		
<b>Direction:</b> East (Downstream)		
<b>Description:</b>  View of Watercourse Pocono Creek (WW-3-00) facing downstream.

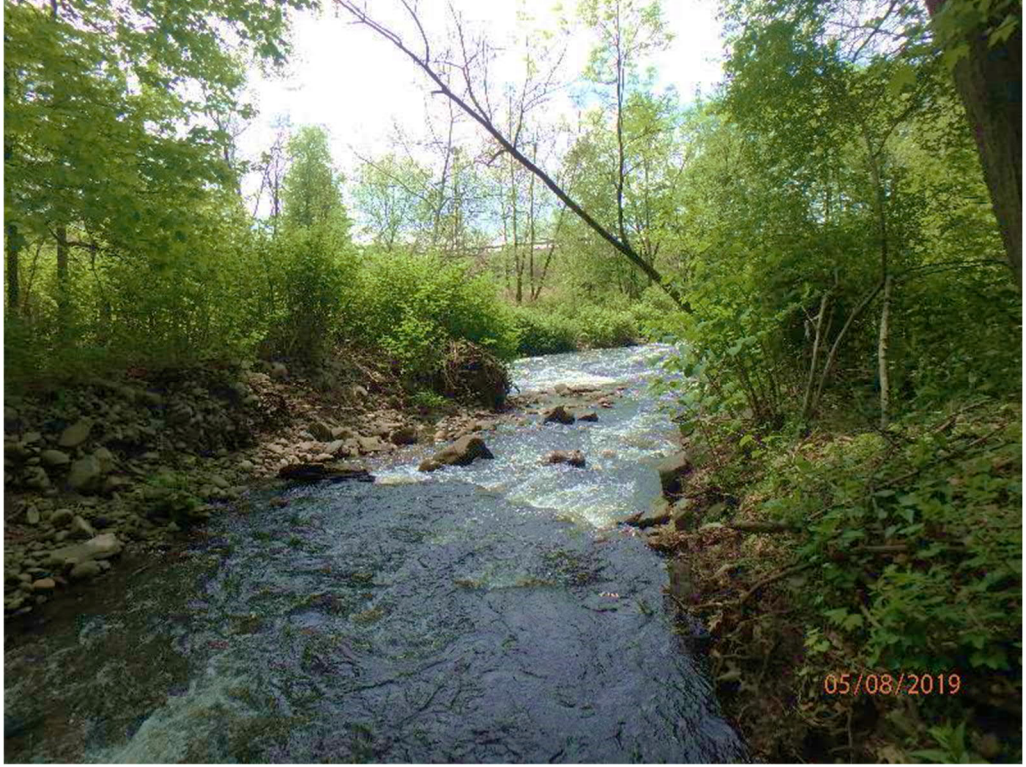
<b>Photograph:</b> 4	<b>Date:</b> 05/08/2019

<b>Feature ID:</b> Watercourse WW-3-04		
<b>Direction:</b> South (Downstream)		
<b>Description:</b>  View of Watercourse Flagler Run (WW-3-04) facing downstream.

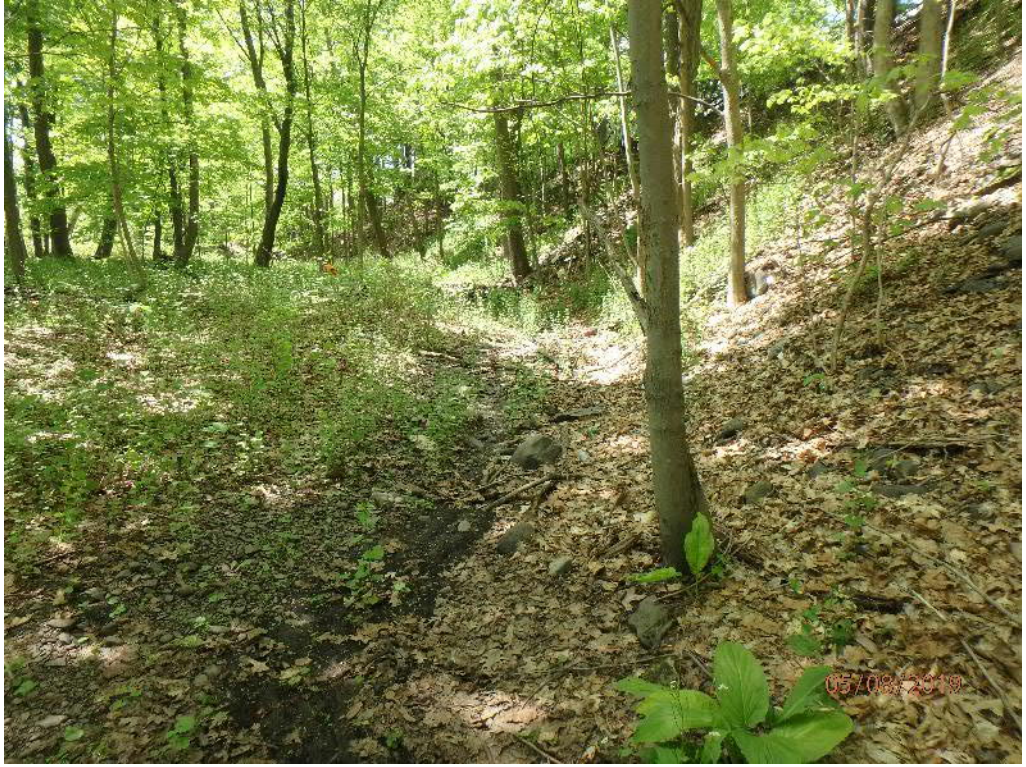
<b>Photograph:</b> 5	<b>Date:</b> 05/08/2019

<b>Feature ID:</b> Watercourse WW-3-20		
<b>Direction:</b> Northwest (Upstream)		
<b>Description:</b>  View of Watercourse UNT to Pocono Creek (WW-3-20) facing upstream.

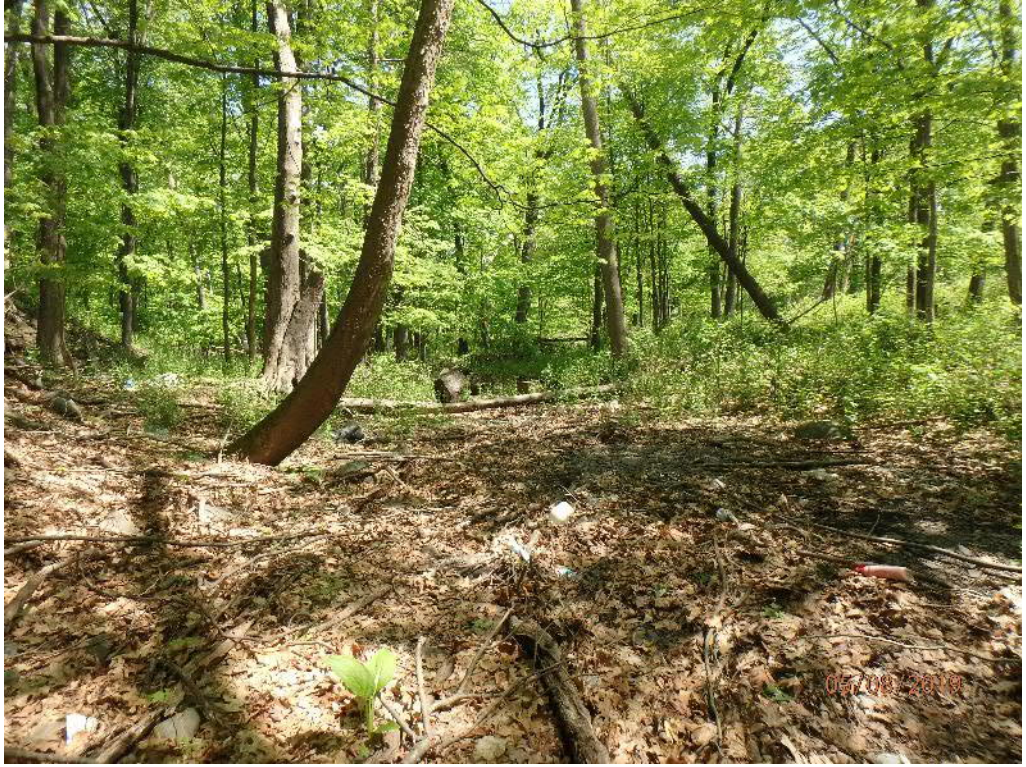
<b>Photograph:</b> 6	<b>Date:</b> 05/08/2019

<b>Feature ID:</b> Watercourse WW-3-20		
<b>Direction:</b> Southeast (Downstream)		
<b>Description:</b>  View of Watercourse UNT to Pocono Creek (WW-3-20) facing downstream.

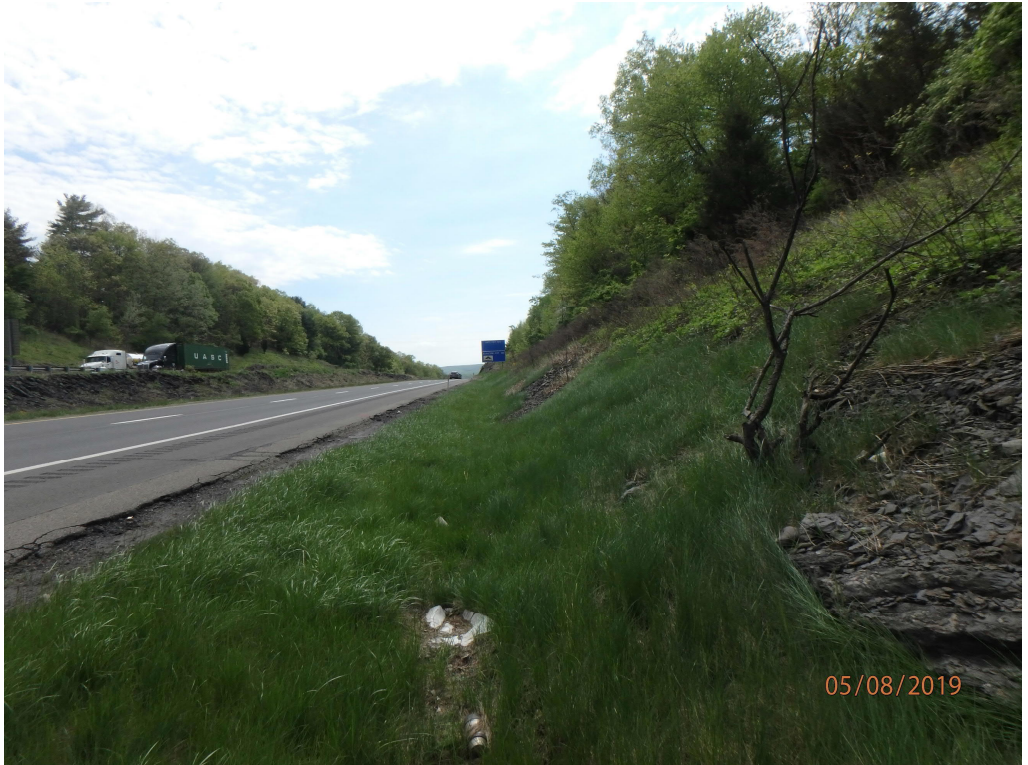
<b>Photograph:</b> 9	<b>Date:</b> 05/08/2019

<b>Feature ID:</b> Upland		
<b>Direction:</b> East		
<b>Description:</b>  View of the typical upland conditions within the I-80 Western Extension Area, south of I-80.

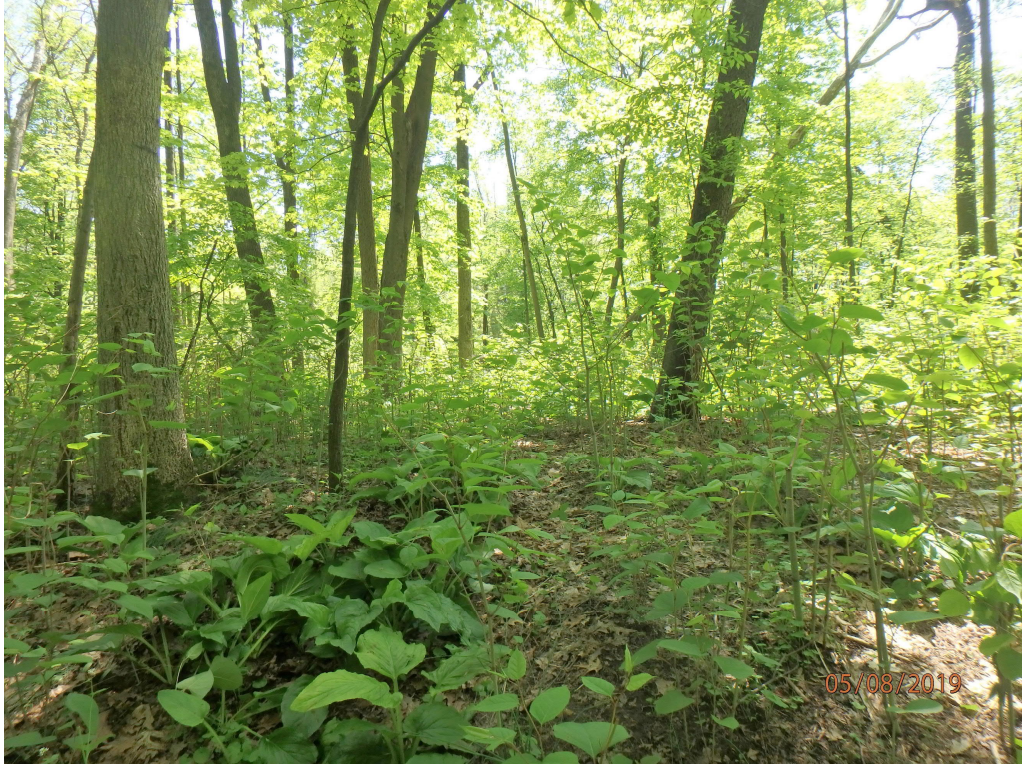
<b>Photograph:</b> 11	<b>Date:</b> 05/08/2019

<b>Feature ID:</b> Upland		
<b>Direction:</b> South		
<b>Description:</b>  View of the typical upland conditions within the Exit 304 Ramp I Area, at Sampling Point 2.
