Interstate 80, Section 17M

Water Resources Delineation Report 2018 Addendum - Expanded Study Area

January 2018

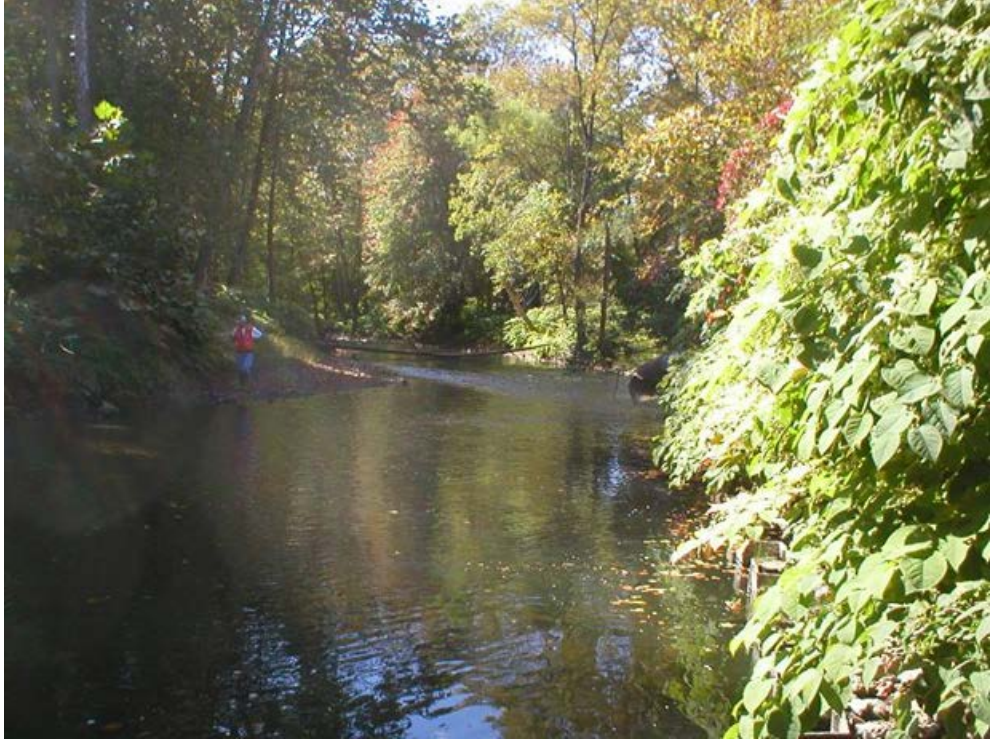
Photograph: 39	Date: 09/18/13

Feature ID: Watercourse WW-2-00		
Direction: West (Upstream)		
Description: View of watercourse McMichael Creek (WW-2-00) facing west upstream.

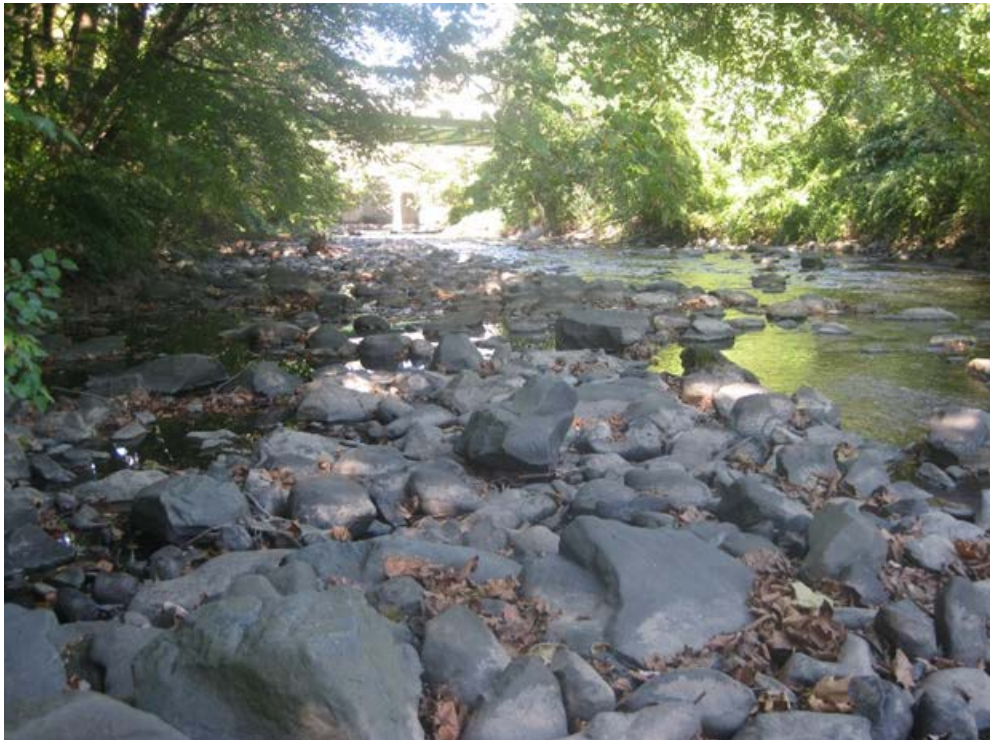
Photograph: 66	Date: 09/18/13

Feature ID: Watercourse WW-3-00		
Direction: N/A		
Description: View of watercourse Pocono Creek (WW-3-00) facing west upstream.

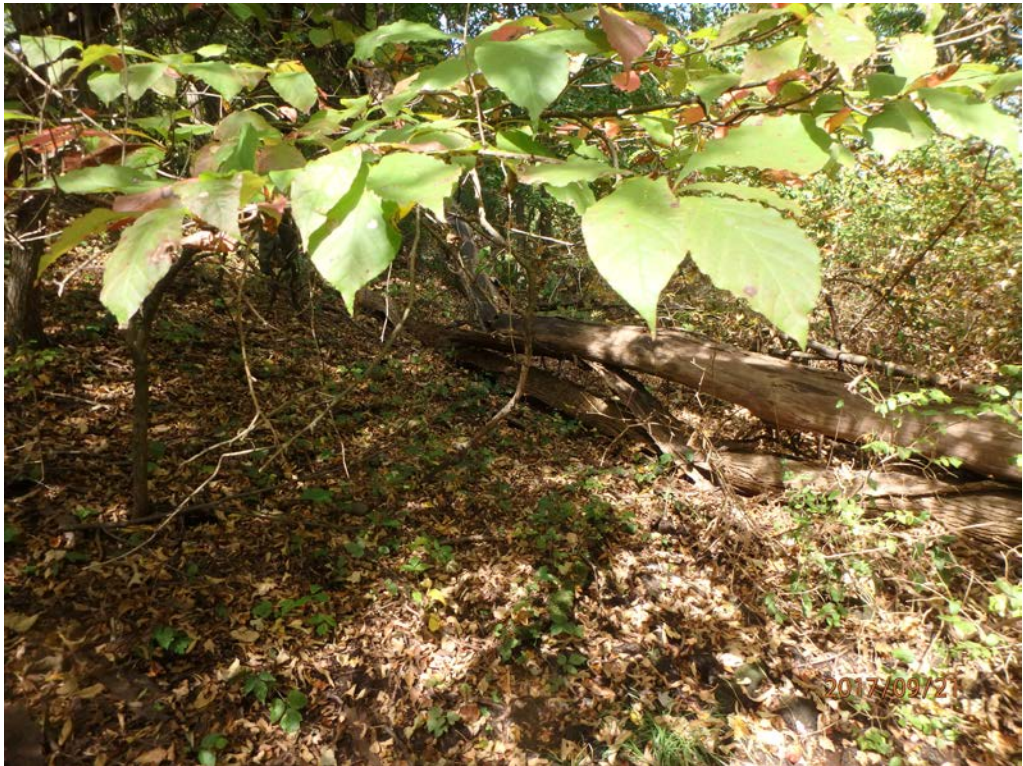
Photograph: 102	Date: 09/21/17

Feature ID: W-3-14a		
Direction: North		
Description: View of wetland W-3-14a facing south from the wetland data point.
