**Addendum Phase IB Archaeological Identification Survey
Negative Survey Form**

**I-80 Reconstruction Project
Monroe County, Pennsylvania**

ER# 2013-8131-089

September 2018

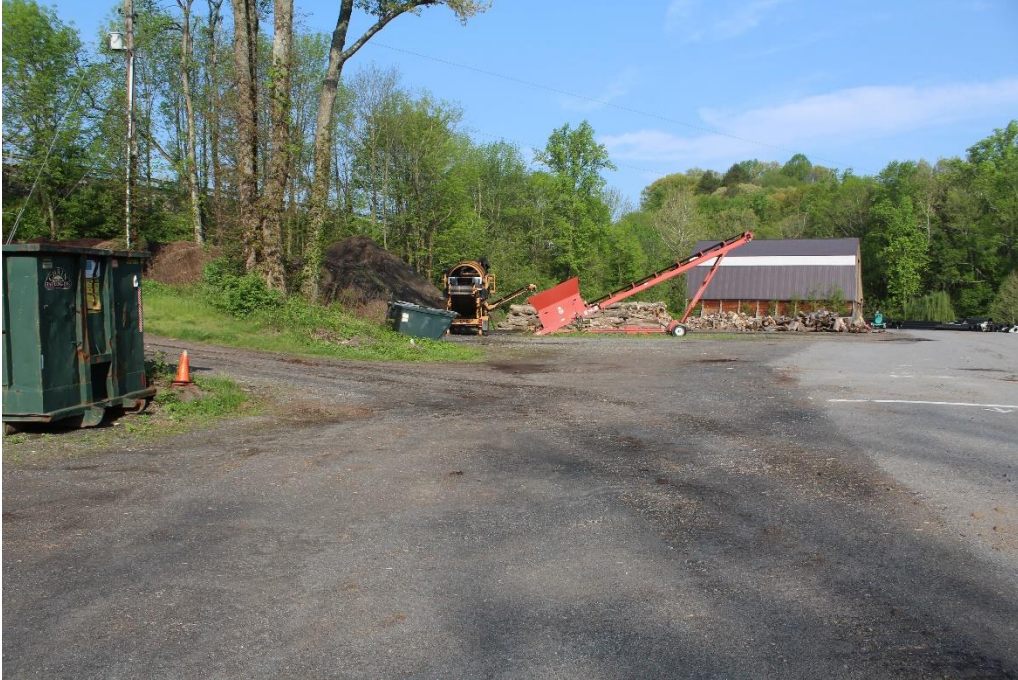
Photograph 1: General view of previous disturbance observed within Basin 1053, facing west. Basin 1053 was not subjected to subsurface testing.

The majority of the proposed basin locations are within areas observed to have been subjected to previous disturbance in association with roadway and/or industrial/commercial development. Specifically, these locations include Basins 1053, 1120, 1125, 1155, and 1184. No subsurface testing was conducted within these locations. Observed disturbance was photo-documented. Representative photographs of the encountered disturbance are provided in Attachment D (Photographs 1, 2, 3, 4, and 5).

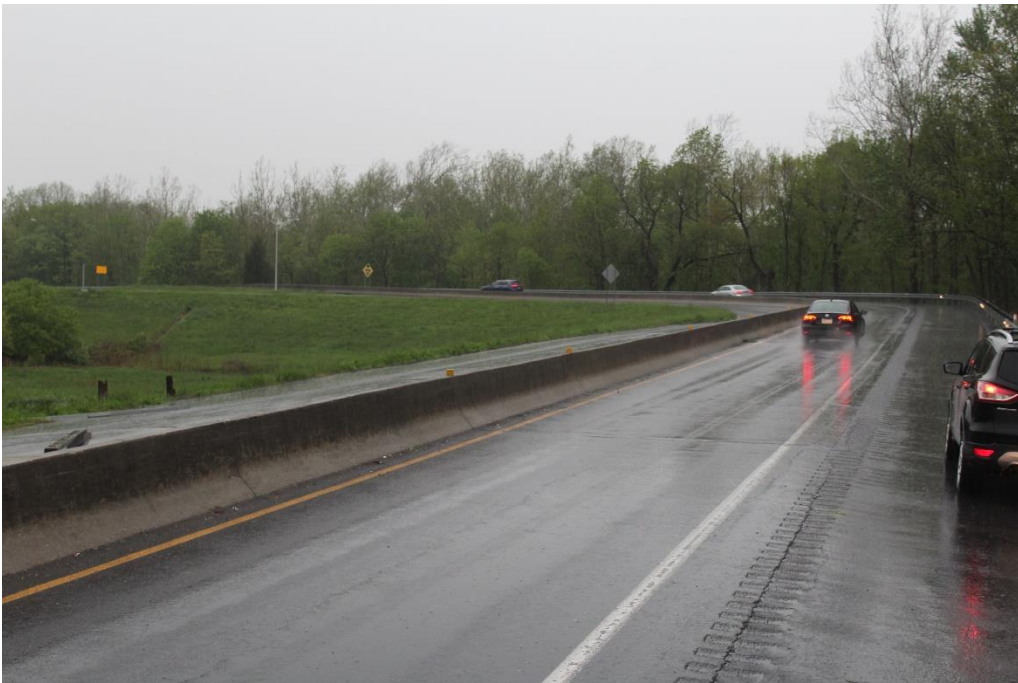
Photograph 2: General view of previous disturbance observed within Basin 1120, facing northwest. Basin 1120 was not subjected to subsurface testing.

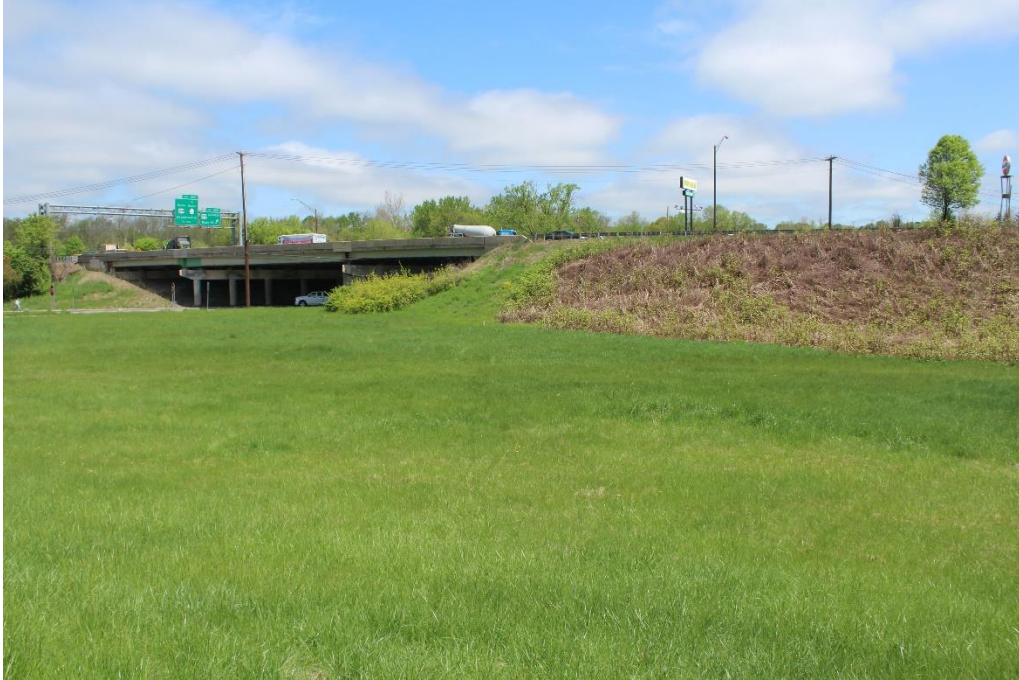
Photograph 3: General view of previous disturbance observed within Basin 1125, facing north.
Basin 1125 was not subjected to subsurface testing.

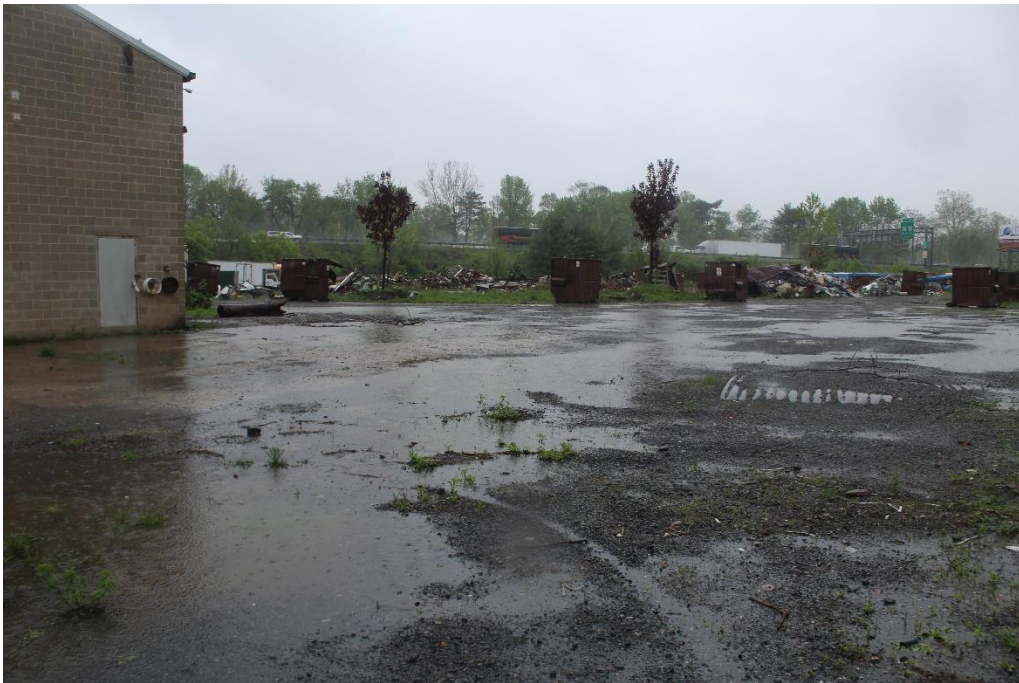
Photograph 4: General view of previous disturbance observed within Basin 1155, facing north.
Basin 1155 was not subjected to subsurface testing.

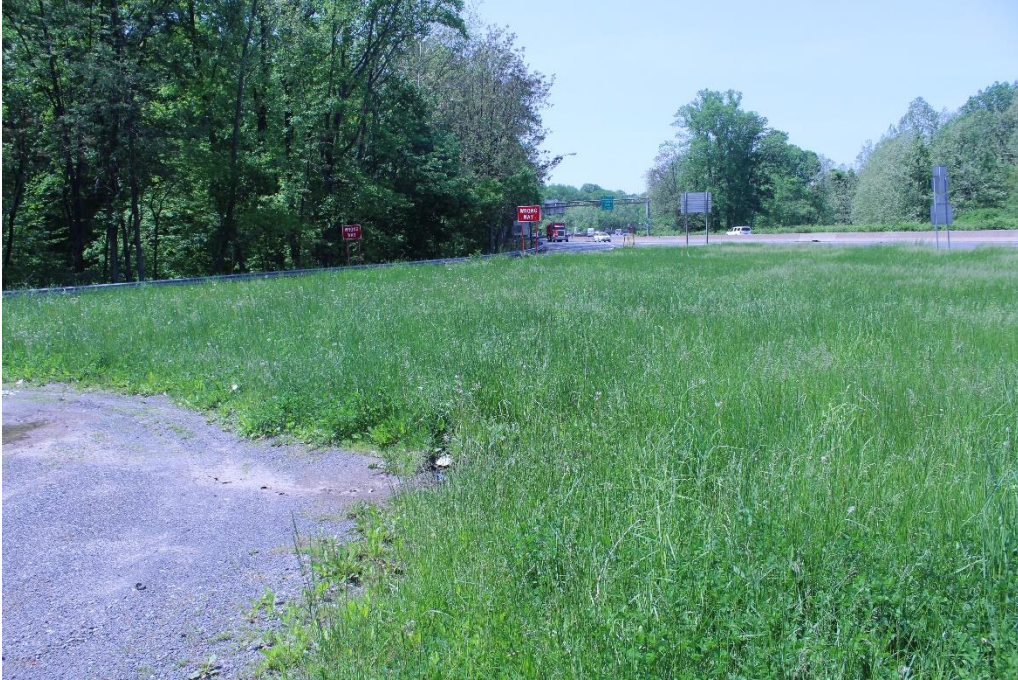
Photograph 5: General view of previous disturbance observed within Basin 1184, facing southwest. Basin 1184 was not subjected to subsurface testing.

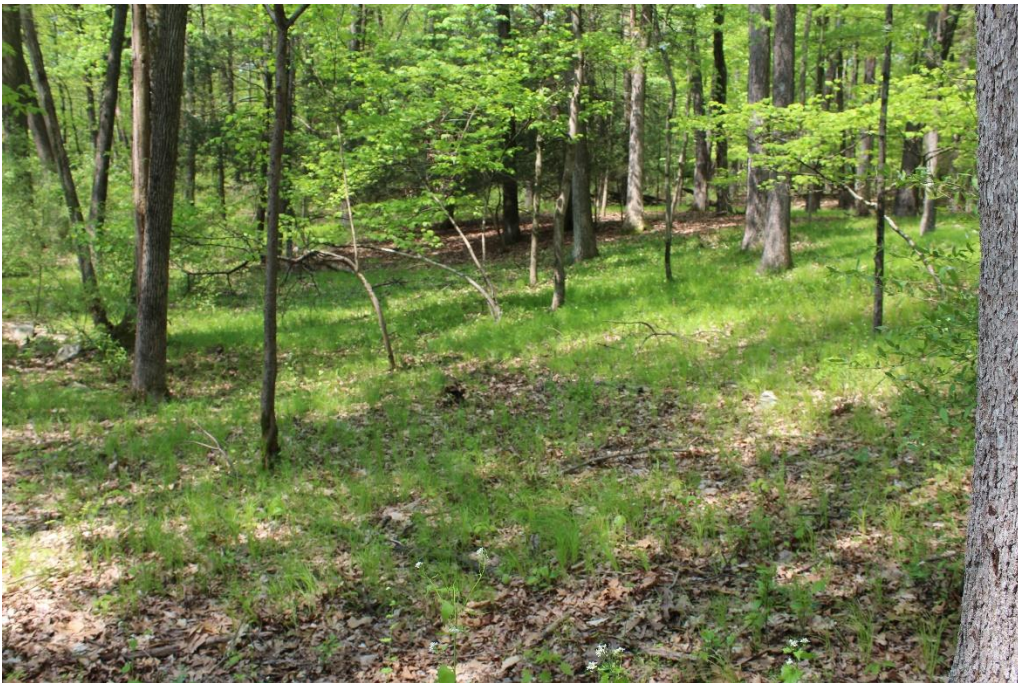
Basin 1030 is located at the western project terminus and is situated on a relatively flat low lying area south of the I-80 corridor (Photograph 6). Basin 1030 exhibited steep slopes at the eastern and western extent of the basin. Five (5) STPs 212-216 were excavated within Basin 1030. Soil profiles revealed stacked fills; the majority of the STPs were refused by rock at ~1.5 feet bgs. Based on the rounded cobbles and iron staining encountered within the lower reaches of these tests, it is likely that this area previously functioned as a wetland and was infilled in association with the construction of the I-80 corridor. No cultural material was recovered.

Photograph 6: General view of Basin 1030 situated south of the I-80 corridor, facing southwest. Steep slopes were present in the eastern and western extent of the basin.

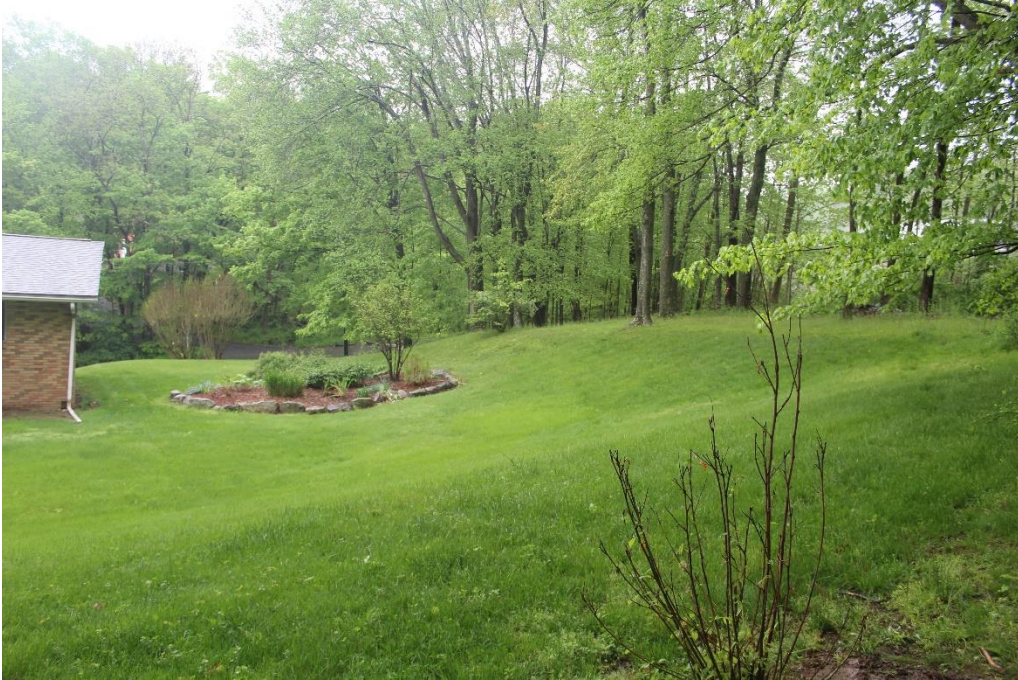
Basin 1040 is also located near the western project terminus, east of White Stone Corner Road. The majority of the basin extent has been disturbed as a result of residential development, including cutting/grading of the rear yard (Photograph 7). STPs 217-226 were excavated within areas of mixed moderate and high probability and yielded predominantly plowed profiles; overlying fill layers were also encountered in the vicinity of the I-80 corridor and refusal within fill was received in the vicinity of the extant 20th century residence. Due to observed disturbance and steep slopes, areas demarcated as exhibiting moderate and high probability within the northern portion of the basin were not subjected to subsurface testing. No cultural material was recovered.

Photograph 7: General view of Basin 1040, facing southeast. The majority of the basin extent has been disturbed as a result of residential development, including cutting/grading of the rear yard.

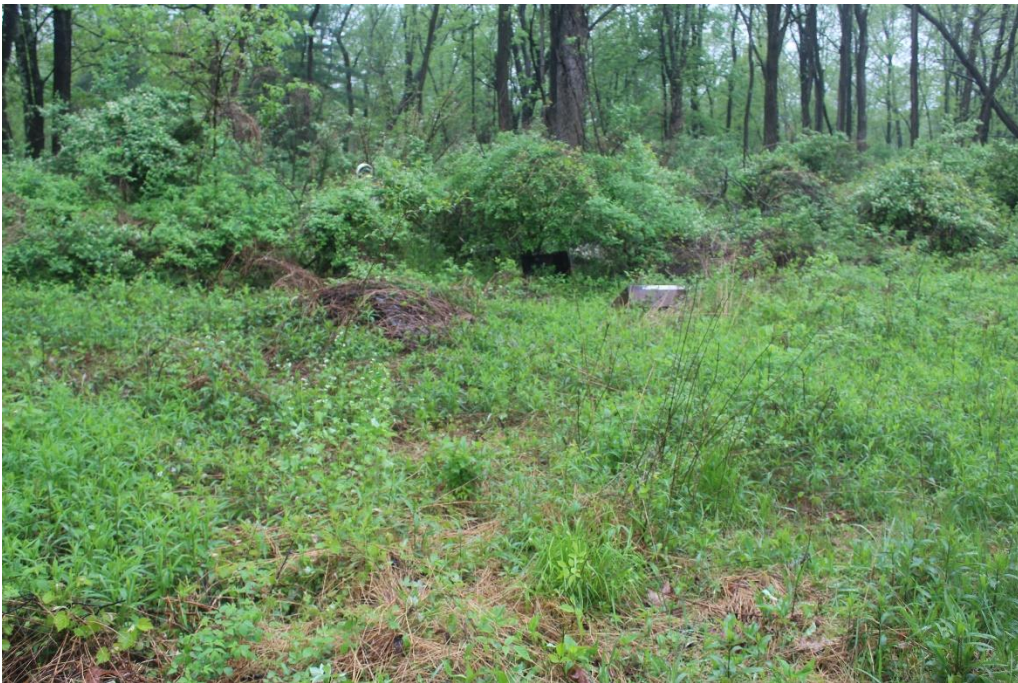
Basin 1080 is located west of Bridge Street within the southwestern quadrant of the I-80 overpass over Pocono Creek (Photograph 8). STPs 227-230 were excavated within an area of moderate archaeological probability. All excavations encountered stacked alluvial deposits. Plastic, miscellaneous glass, and wire nails were recovered; however, due to the poor contexts from which they were recovered, no site was identified.

Photograph 8: General view of Basin 1080 within the southwest quadrant of the I-80 overpass over McMichael Creek, facing southwest. All excavations encountered stacked alluvial deposits.

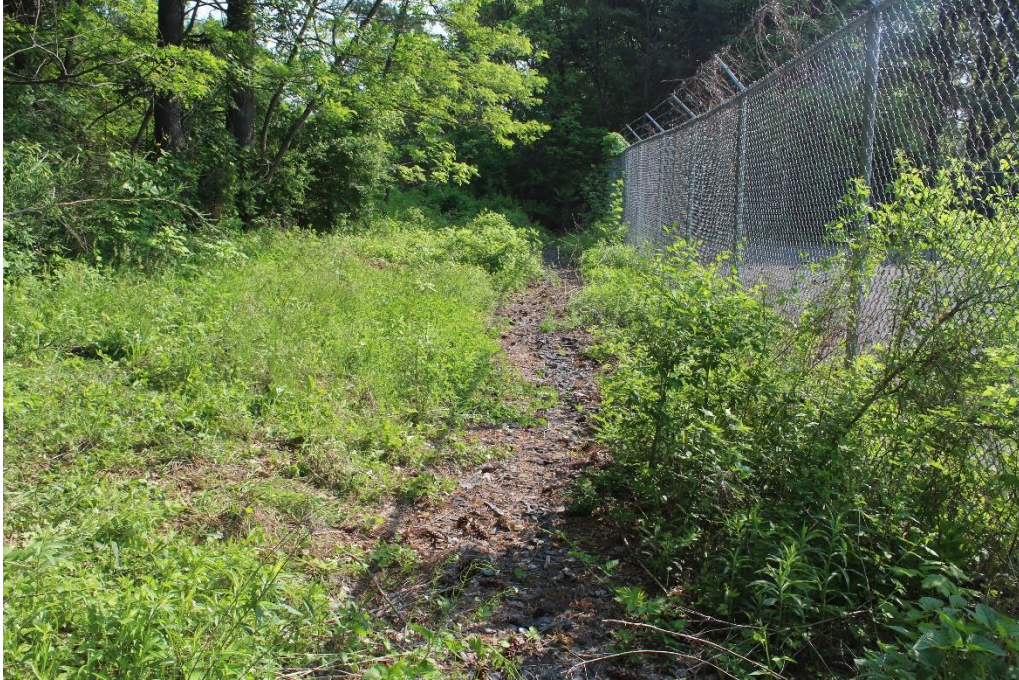
Basin 1095 is located adjacent to Tanite Road west of US 209 (Photograph 9). STPs 231-234 were excavated within an area of high archaeological probability. STPs 231-233 revealed disturbed soil profiles, likely associated with the construction of the current medical facility and parking lot. STP 234, located farther north and east within

an adjacent wooded area, exhibited a plowed, relatively undisturbed profile. Artifacts, including wire nails, aluminum, a metal washer, and miscellaneous flat metal, were recovered from the encountered disturbed contexts only and do not constitute an archaeological site.

Photograph 9: General view of Basin 1095, located adjacent to Tanite Road west of US 209, facing northeast. The majority of the basin extent is located within the adjacent parking lot. Disturbed soil profiles were likely associated with the construction of the adjacent medical facility and parking lot.

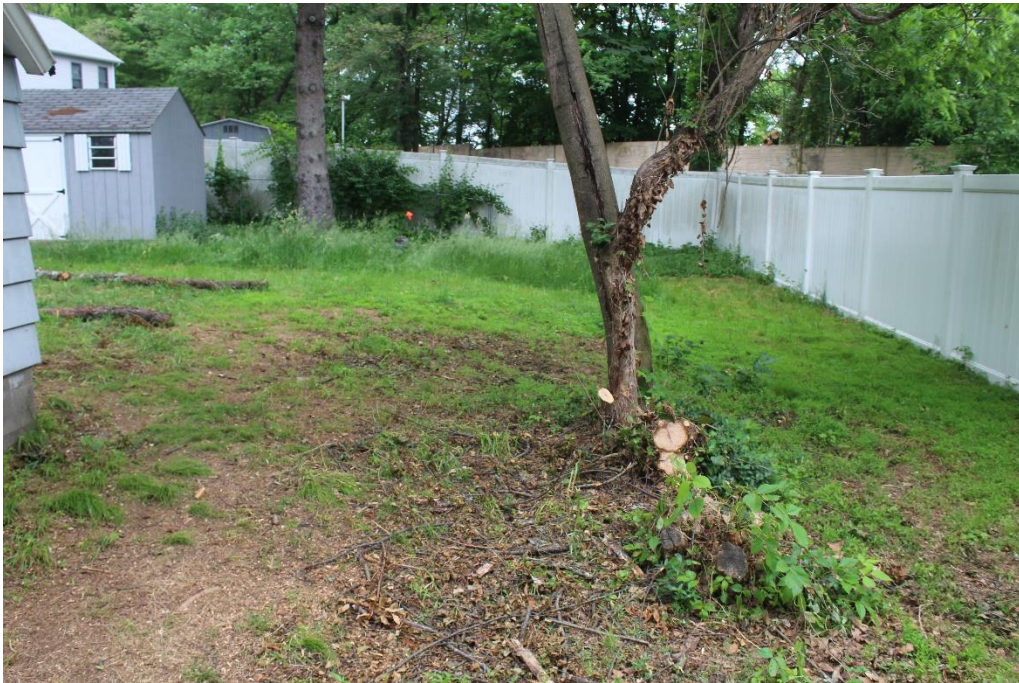
STPs excavated within Basin 1140, in the rear yards of the properties/parcels associated with 1222 and 1224 Dreher Avenue, revealed disturbed soil profiles, indicating that the rear yards had been stripped/graded (Photographs 10 and 11). STPs 237-239 and 241-243 exhibited deep fill disturbance (some refused on cobbles/fill, some overlying an intact B horizon, and one excavated to 3.3 ft). In two instances (STPs 238 and 241), the fills were found to overlie very thin truncated Ap horizons. Cultural material recovered from the Ap remnants consisted of brick fragments (n=2), wire nails (n=3), and single examples of window glass, terra cotta, and lantern glass. These materials likely represent field scatter or redeposition within the Ap horizon by the mechanized placement of the overlying fill. One pre-contact flake was recovered from STP 238; however, the artifact was recovered from an historic fill disturbance. Relatively undisturbed plowed soil profiles were encountered at greater distance from the residences (STPs 235, 236, and 240).

Photograph 10: General view of high probability area within Basin 1140 (rear yard of 1224 Dreher Avenue), facing west.

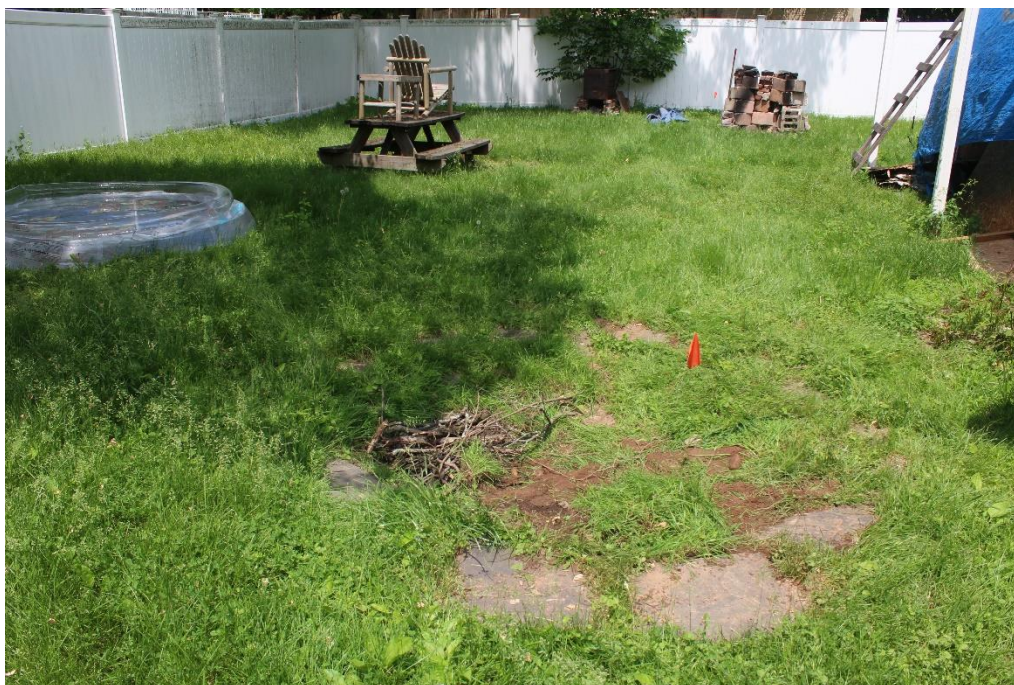
Photograph 11: General view of high probability area within Basin 1140 (rear yard of 1222 Dreher Avenue), facing northwest.

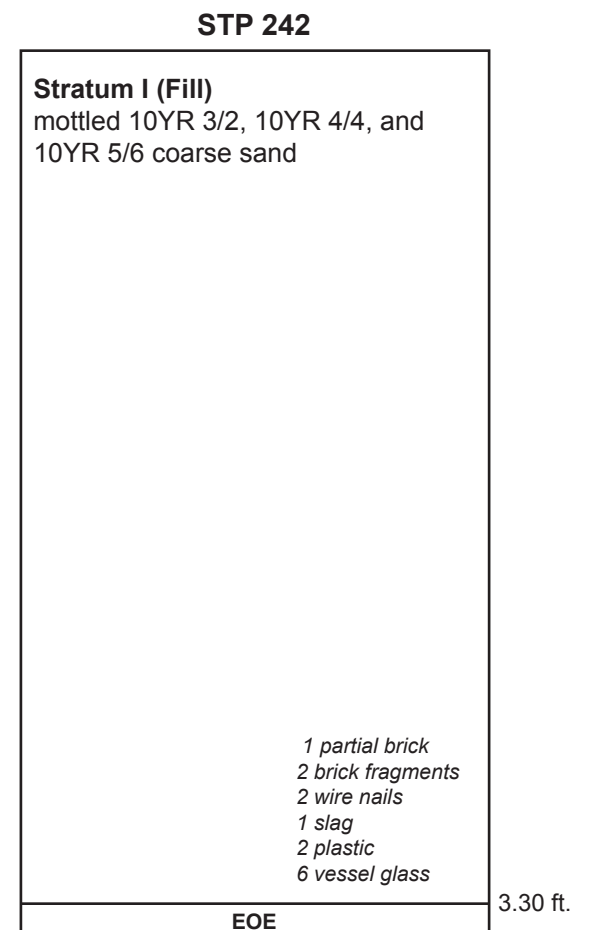
Attachment E
Representative Shovel Test Pit Profiles:
Addendum Phase IB Archaeological Survey
I-80 Reconstruction Project
Stroudsburg Borough and Stroud Township
Monroe County, Pennsylvania

A total of 32 STPs (STPs 212-243) were excavated as part of the Addendum Phase IB survey. Representative soil profiles are provided in Attachment E. No archaeological sites were identified. Cultural material encountered during the survey was recovered from fill contexts and were determined to not represent intact deposits. The majority of the historic material consisted of wire nails, vessel glass, and brick fragments. One pre-contact flake was recovered from STP 238; however, the artifact was recovered from an historic fill disturbance. No radial STPs were excavated.

All STPs were 0.52 meters (1.7 feet) in diameter and were excavated by natural strata. The STPs were excavated to a maximum depth of one meter. Excavated soils were screened through ¼ inch hardware cloth. All excavations within an identified T1 terrace extended to the top of relict lateral accretion deposits. All excavations within the upland valley slopes extended at least 0.10 meters (~0.33 feet) into sterile subsoil. The soil profiles for the STPs were recorded on a standardized form using Munsell color designations and U.S. Department of Agriculture soil texture terminology. All recovered artifacts were segregated by stratigraphic context.
